Boatman's Notes

The ultimate Med wood finish test

BY RICHARD HARE

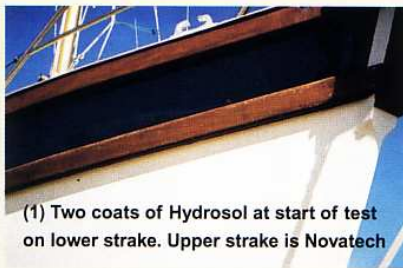
(1) Two coats of Hydrosol at start of test on lower strake. Upper strake is Novatech

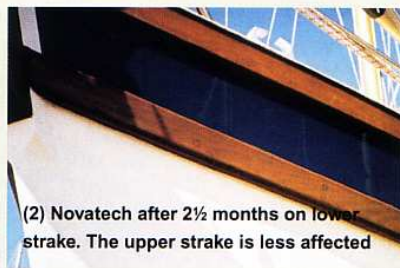
(2) Novatech after 2½ months on lower strake. The upper strake is less affected

to cut the mustard on the strake. Although its outward- and downward-facing surfaces performed OK, it was the upper-facing surface of the strake (which faces into the strong sun, and probably accumulates the most salt) that broke up. Although it performed better than the Hydrosol (it did have three coats as opposed to two), we can't recommend it for below-gunwales use in the Med. It remains a *Classic Boat* Pass+1 Premium product.

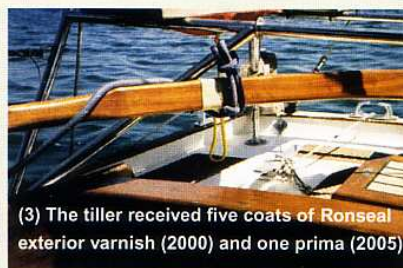
(3) The tiller received five coats of Ronseal exterior varnish (2000) and one prima (2005)

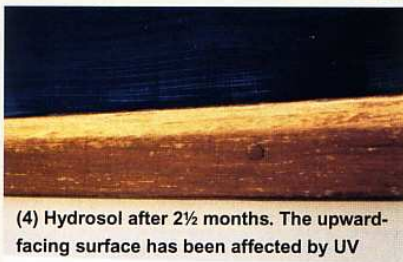
(4) Hydrosol after 2½ months. The upward-facing surface has been affected by UV

Despite the water-based Woodsealer Hydrosol being a test rig pass – and probably a good performer in a northern European sea environment (weak UV/low salinity and plenty of cleansing rain) – about 40 per cent of it had disappeared after only a 2½-month trip around the Peloponnisos. Had we tested it on a lake or an inland

waterway it might have been fine. But, despite it remaining a *Classic Boat* 'pass' product, it didn't perform well when put in the worst possible conditions. That isn't to say that it wouldn't have done a lot better in an above-gunwales situation – coamings, grabrails, hatches, for example. Either way, the remnants were removed from the strake to clear the decks for something else.

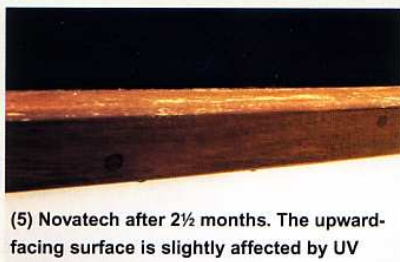
(5) Novatech after 2½ months. The upward-facing surface is slightly affected by UV

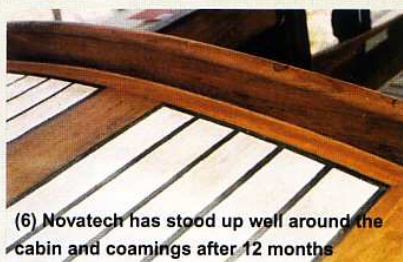
(6) Novatech has stood up well around the cabin and coamings after 12 months

And it was above the gunwales that Novatech continues to perform very well (see Photo 6). Alas, it, too, failed

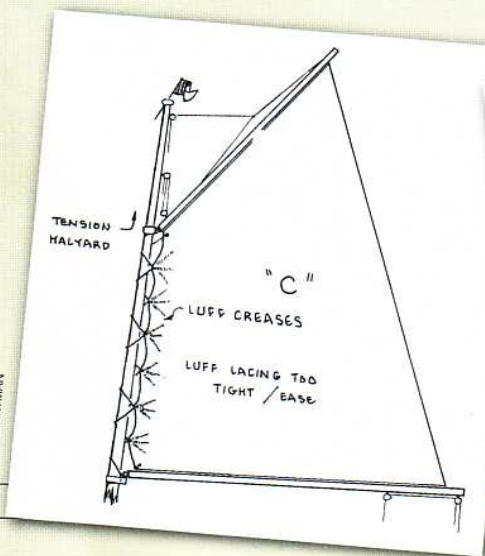
Picture C shows creases down the luff of the sail, caused either by the luff

lacing being too tight or insufficient tension in the throat halyard. You will need to relax the luff lacing and/or increase the tension in the throat halyard.

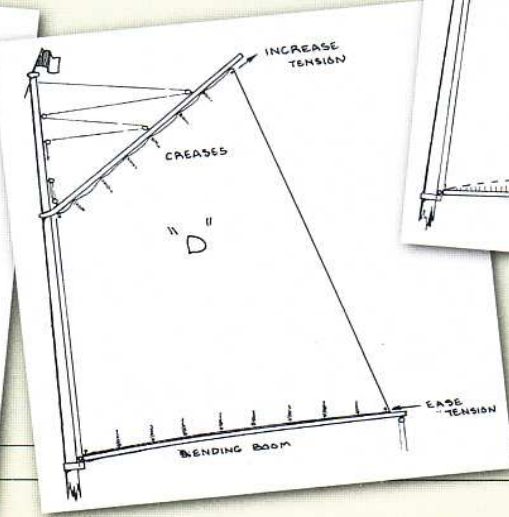
Picture D shows creasing at 90 degrees to the gaff or boom, for which you will need to increase the head and/or clew outhaul tension. Or you could try easing the lacing in the areas where there is creasing as it could be that the spar is bending more than desired.

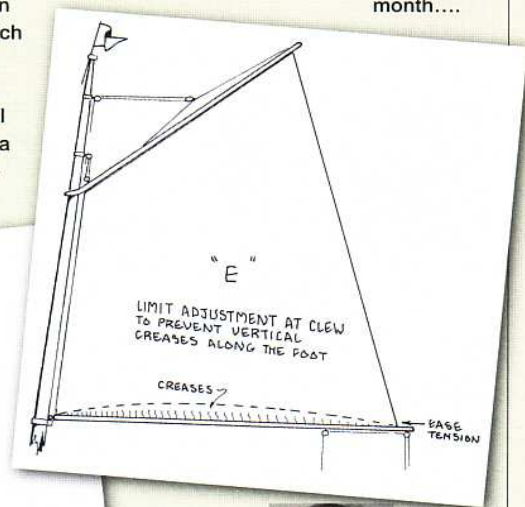
Picture E shows creases from tack to clew, usually caused by the clew tension being too tight. In this instance you will need to ease the clew outhaul. However, it is possible that if you do this, you may end up with the 90-degree creases shown in Picture D, in which case your sail ropes may need adjusting. All sail ropes stretch to a certain degree –

but when they are overstretched it becomes impossible to set your sail correctly. It is, however, a relatively straightforward process for your sailmaker to rectify this.
