Varnish test: Six months on

Six months into our latest exterior woodfinish test, former TRADA wood technologist *Richard Hare* assesses the preliminary findings. We really didn't think there would be anything worth reporting, but how wrong we were.

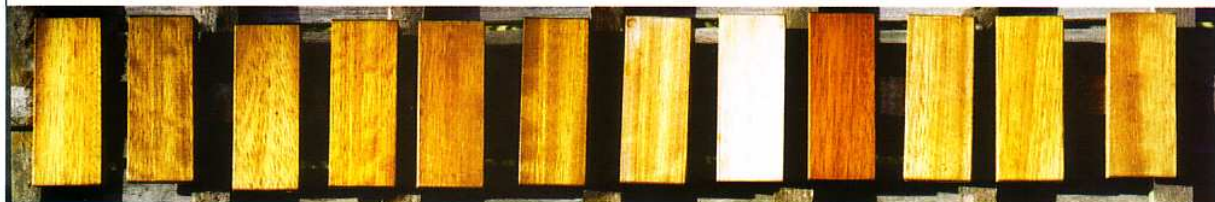
SIX MONTHS INTO TEST

The finish is totally intact on the surface and on all four edges. Impressive gloss remains. On one test piece, a shard of varnish has dislodged from the surface of the khaya sample. Since the finish is performing excellently on the notoriously more difficult to coat iroko, we suspect that the defect is due to faulty application. We are convinced that it would be a distraction to read anything into this.

Totally intact on the surface and on all four edges. Impressive gloss remains.

Totally intact on the surface and on all four edges. Impressive gloss remains. The system appears to have darkened slightly on the khaya test piece.

There is only an iroko test piece to assess here. It is totally intact on the surface, although the uppermost end-grain edge is becoming weathered. One side is showing signs of beginning to turn grey.

The film on the iroko test piece is showing signs of wearing through, although it does, just, remain intact on the khaya sample.

The end-grain edges of the uppermost surface are particularly weathered grey on both samples.

Both test pieces are almost completely weathered grey although it is marginally better on the khaya.

Given the test criteria, it has failed.

Totally intact on the surface and all four edges. A slight sheen remains. The finish of both samples appears to have darkened slightly.

Totally intact on the surface and all four edges. An impressive gloss remains.

There's nothing wrong with leaving wood to weather grey, as it may last longer than if it were covered by a flawed, impervious system. However, it's not much good to those who want a proper wet-look. As for samples which have weathered grey on the end-grains (7 and 12) we can expect moisture and rainwater to gain access behind the surface film and exploit this bridge-head. However, we can also anticipate that microporous films should cope with this better than impervious systems. We'll have to wait and see.

To meet our test's conditions (CB 188), the products that show signs of damage at this stage will be retested in order to confirm the results and to eliminate any flaws in the testing procedure.
